Fatal accidents:

Scheduled passenger services

Significant non-fatal accidents/incidents:

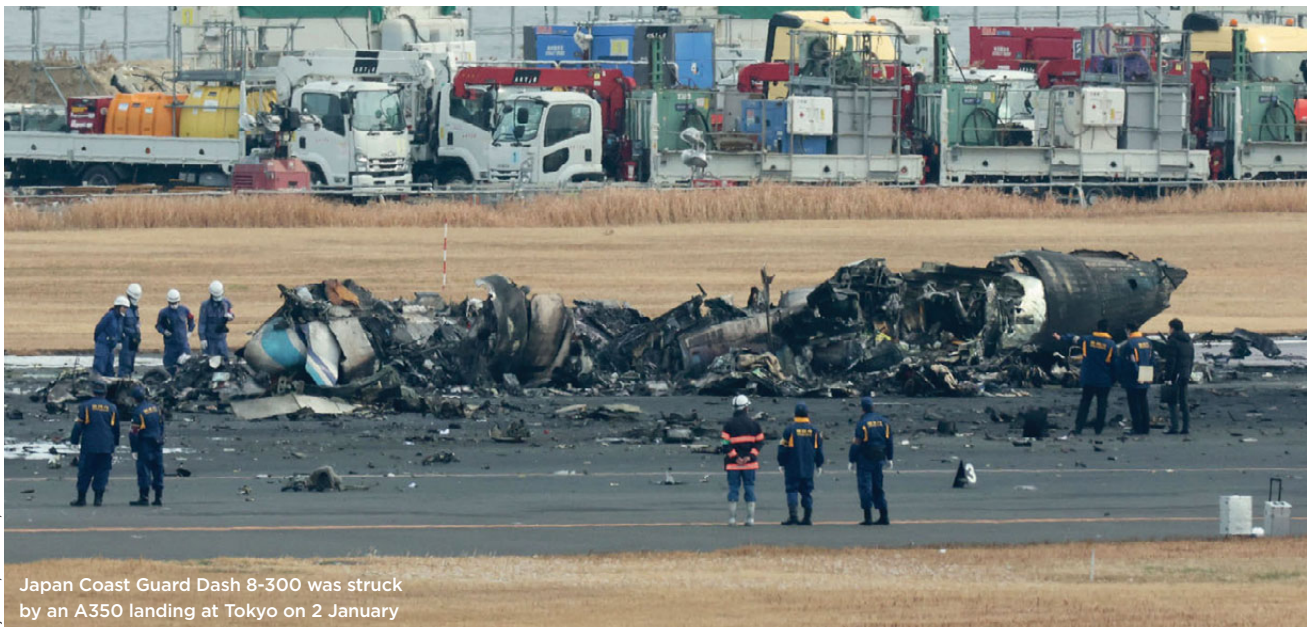
Japan Coast Guard Dash 8-300 was struck by an A350 landing at Tokyo on 2 January

Inbound on a domestic flight from New Chitose airport, Sapporo, the aircraft was cleared to land on runway 34R at Tokyo Haneda. It was a night approach in good visibility. Meanwhile, a Japan Coast Guard De Havilland Canada Dash 8-300 (JA722A) was routing via taxiway C5 intent on taking off from 34R, although it had only been cleared to hold short of the active runway. The Dash 8 lined up on 34R while the A350 was on short final approach, and the Japan Airlines (JAL) crew did not see the small aircraft in the darkness among the plethora of runway lights. The A350 touched down on the runway before colliding with the coastguard aircraft, just as the Dash 8 captain was advancing the power levers. The Dash 8 captain, the only survivor among the crew of six, testified to investigators that he had been cleared for take-off, but air traffic control tapes show he had not been. The stop bar lights for the taxiway

were unserviceable, although this had been notified via NOTAMS. The collision caused the Dash 8 to catch fire immediately, and its wreckage was dragged along the runway for nearly 1,000m (3,280ft), with the badly damaged A350 stopping some 500m beyond it on the grass to the right side of the runway. The JAL aircraft's left engine was on fire, and fire was spreading to the fuselage. Within 3min the Haneda fire and rescue service had reached the aircraft, and the cabin crew were directing the occupants' evacuation via slides at the furthest forward and furthest aft exits on the left-hand side, and the furthest forward exit on the right side – despite the fact the right engine was still running, having not responded to shut-down actions – probably because of damage to avionics systems caused by the collision. All crew and passengers were evacuated without serious injury. The aircraft hull was burned out.

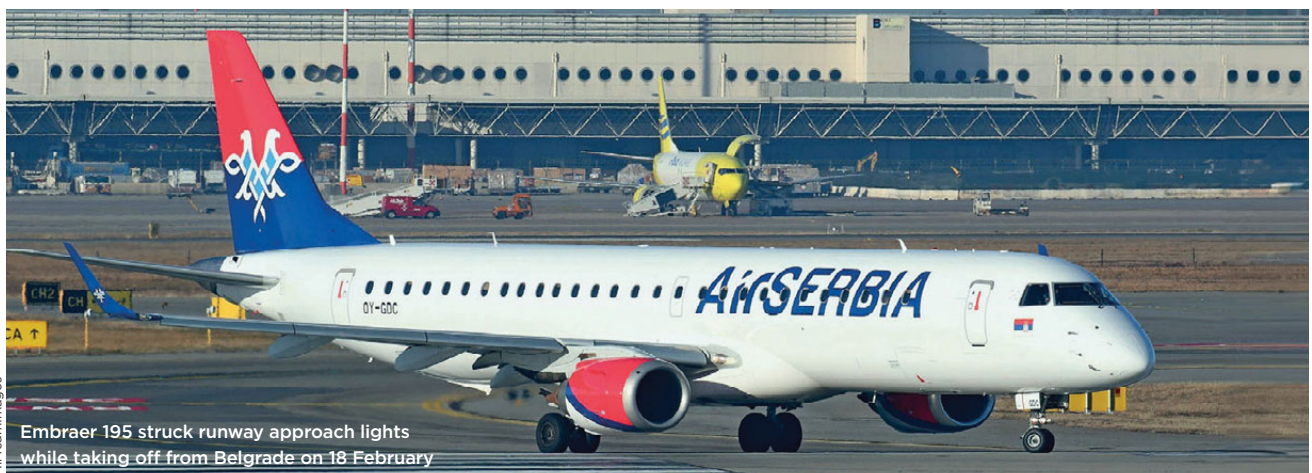
Operating a flight for Air Serbia, the Marathon Airlines crew planned to take off from runway 30L starting the take-off run from intersection D6, having estimated the take-off distance remaining to be 2,349m (7,700ft). When they advised air traffic control (ATC) that they were approaching D6 they were instructed to hold short, then line up and wait. Next, ATC queried whether the crew realised they were at D5, and that the take-off distance available was 1,273m. Having checked their calculated take-off performance using the co-pilot's tablet, they reported ready for take-off from D5, and ATC cleared them confirming there was zero wind. During the take-off run the crew advanced the power levers to maximum, and decided to use all available runway surface beyond the "piano keys"

before rotating. At rotation they heard sounds of impact, felt shaking and unusual slipstream noise, and did not follow the standard instrument departure, requesting a return and then declaring an emergency. They flew the aircraft, with gear deployed, along runway 30L to allow inspection by the tower staff, but no damage could be seen. After making a safe landing, ground crew reported an apparent fuel leak, so the crew shut the aircraft down. Extensive puncture damage was found to the left wing-root fairing and the wing leading edge close to the fuselage, and there was damage to equipment fitted beneath the fairing. The aircraft had hit approach lights for runway 12R and the instrument landing system monitoring antenna, part of which had become embedded.

Embraer 195 struck runway approach lights while taking off from Belgrade on 18 February

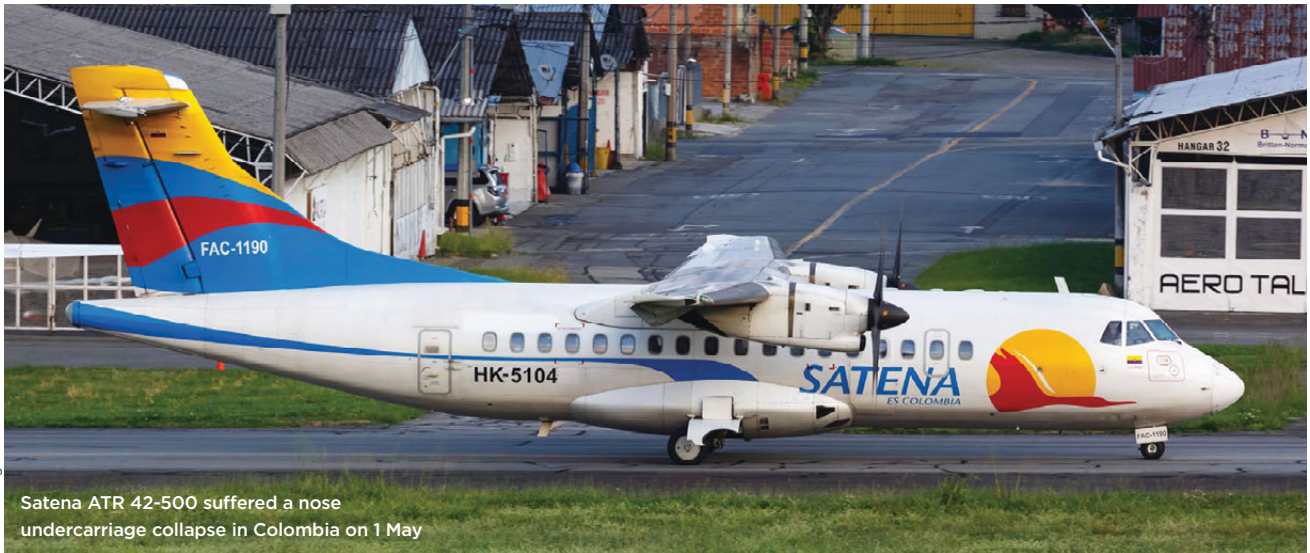
Satena ATR 42-500 suffered a nose undercarriage collapse in Colombia on 1 May

When the crew began carrying out a 180° turn at the runway threshold to line up for departure, the aircraft's nose undercarriage collapsed.

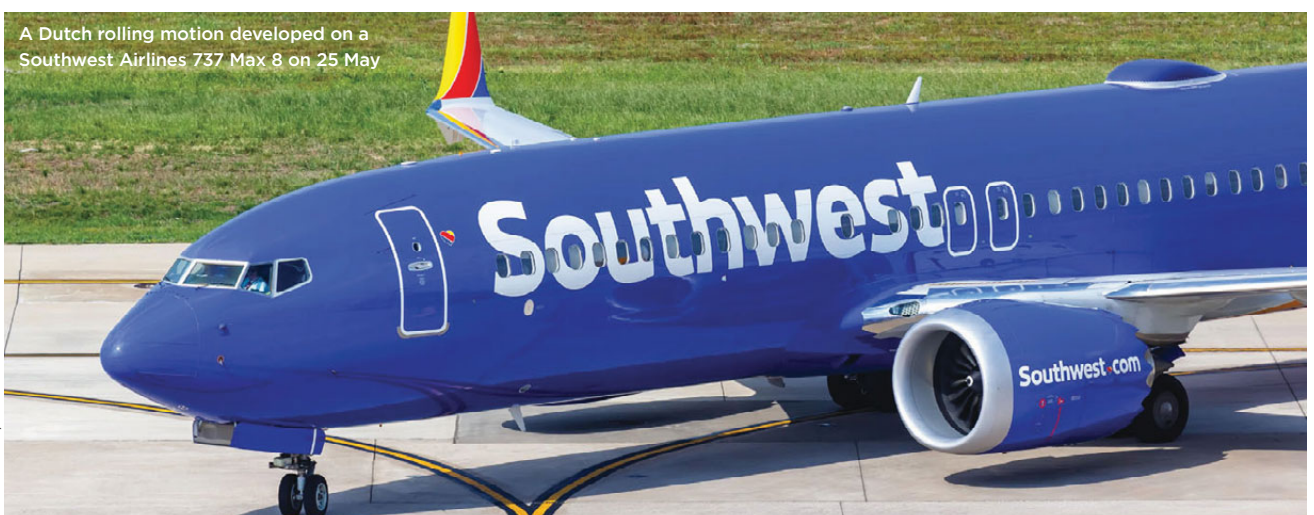
A Dutch rolling motion developed on a Southwest Airlines 737 Max 8 on 25 May
