Fatal accidents:

Scheduled passenger flights

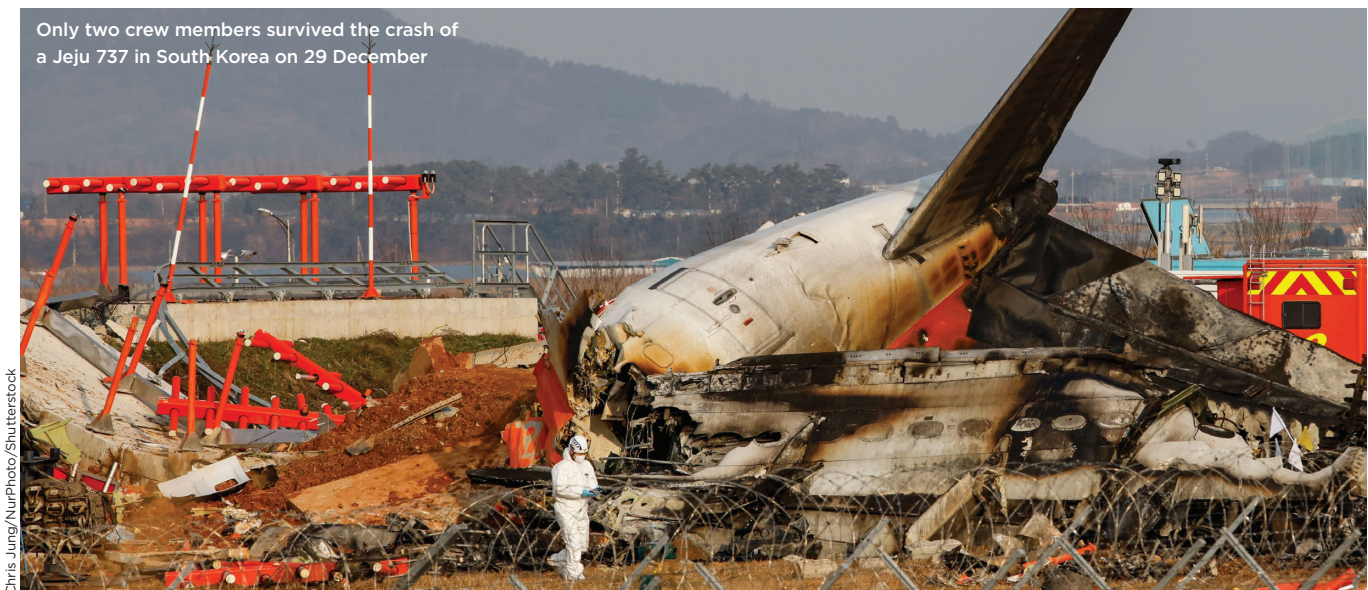
Only two crew members survived the crash of a Jeju 737 in South Korea on 29 December

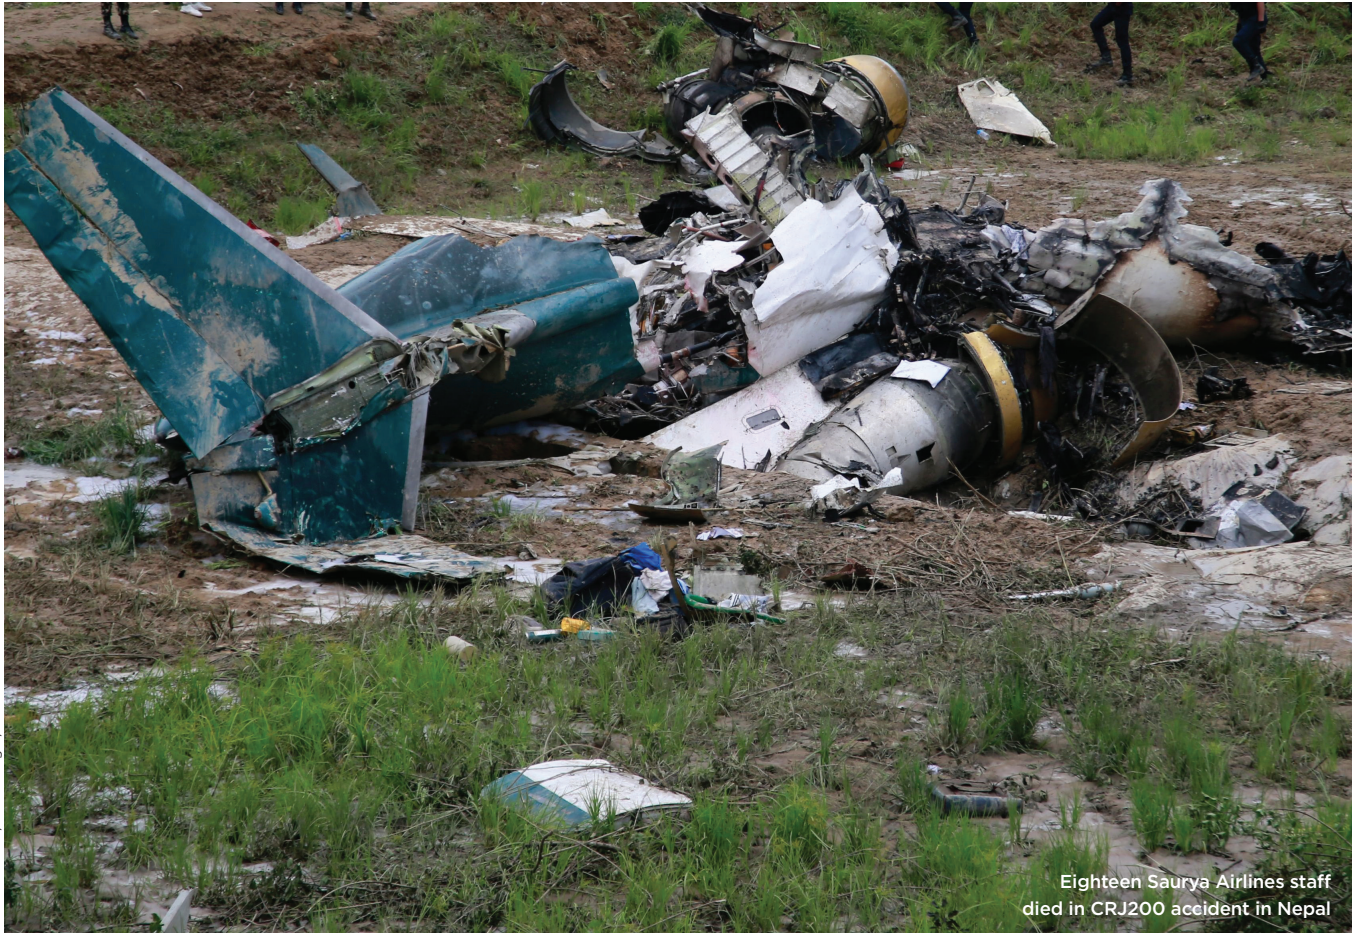
Eighteen Saurya Airlines staff died in CRJ200 accident in Nepal

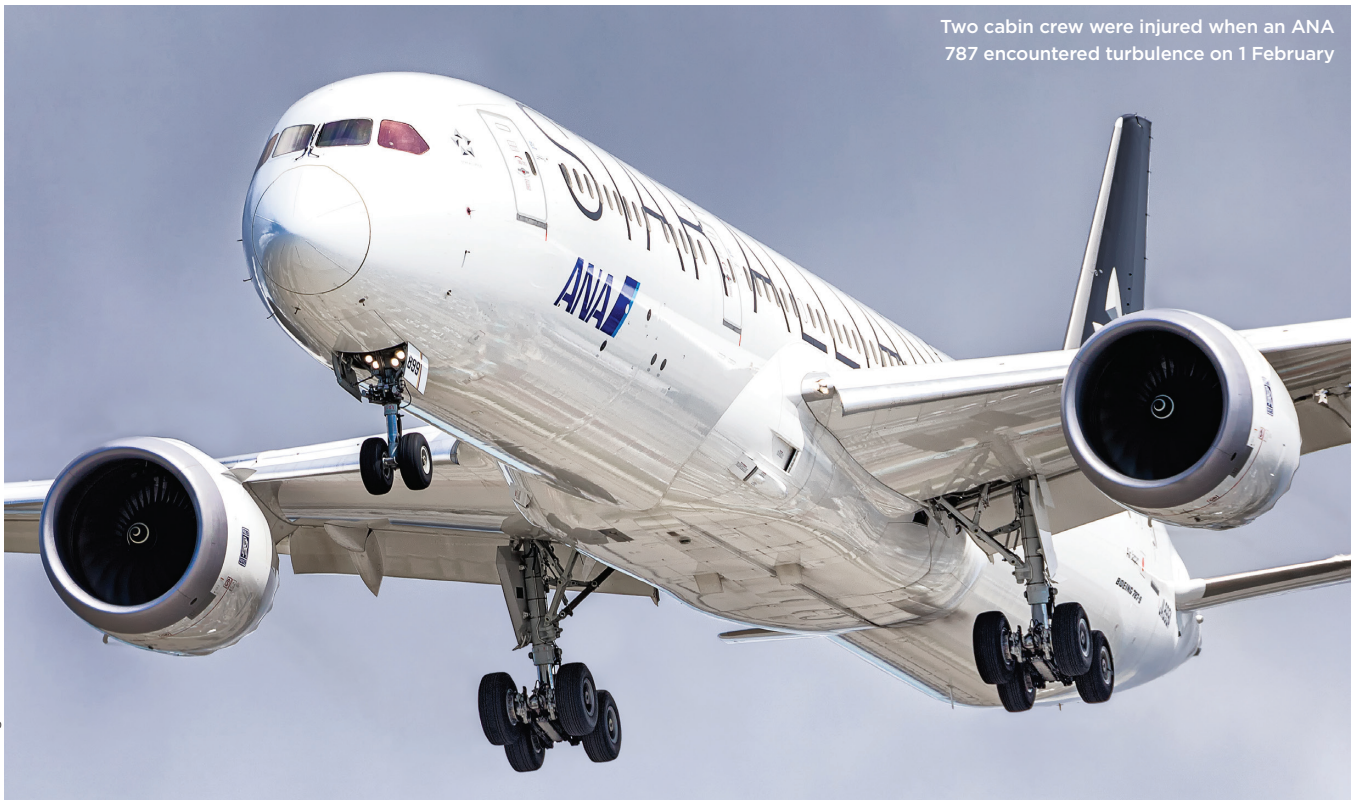
Two cabin crew were injured when an ANA 787 encountered turbulence on 1 February

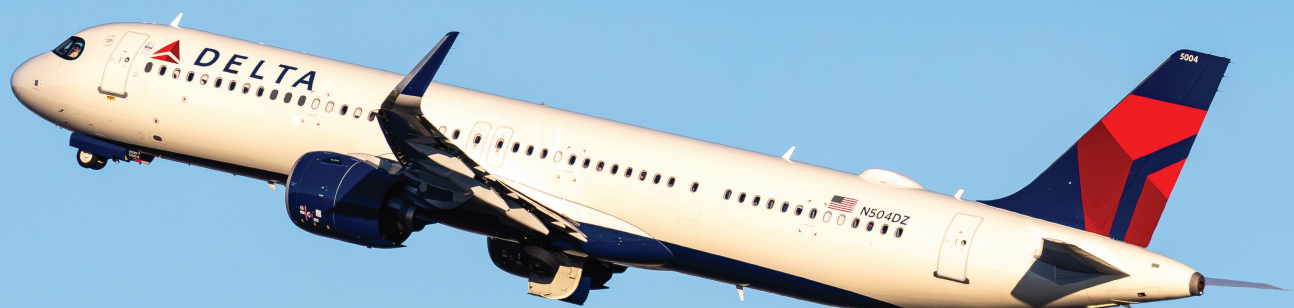
A Delta Air Lines A321neo was damaged by an electrical fire on the ground in May

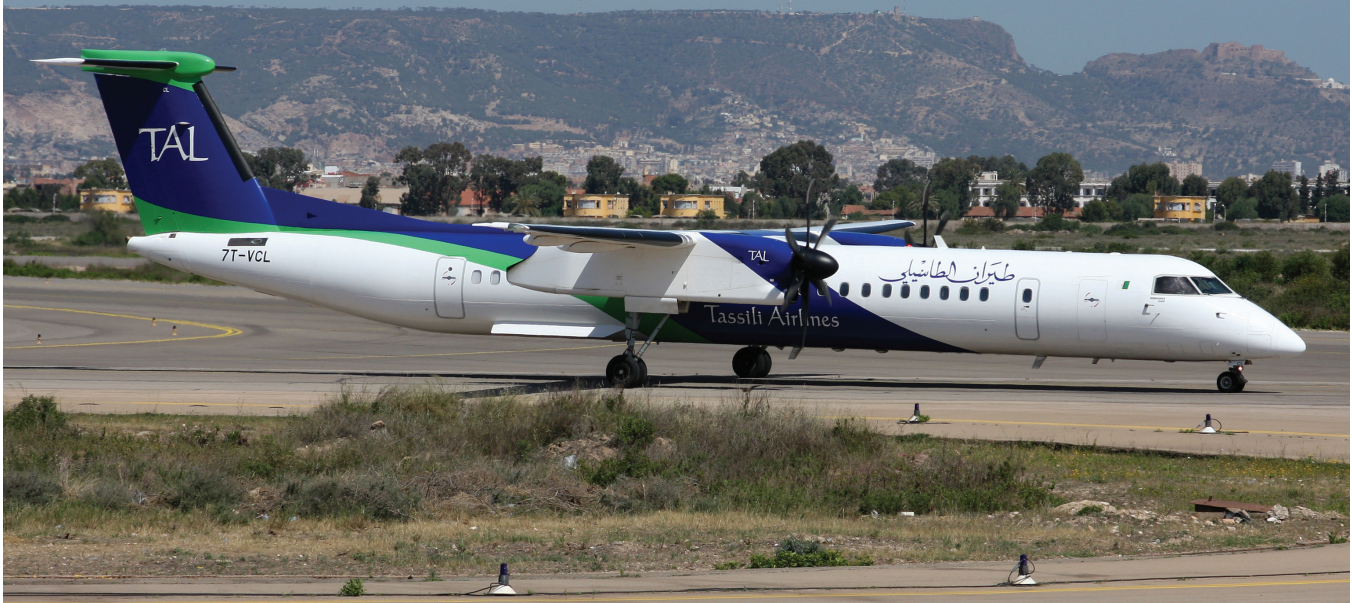
Tyre debris damaged Tassili Airlines Dash 8 on 3 August

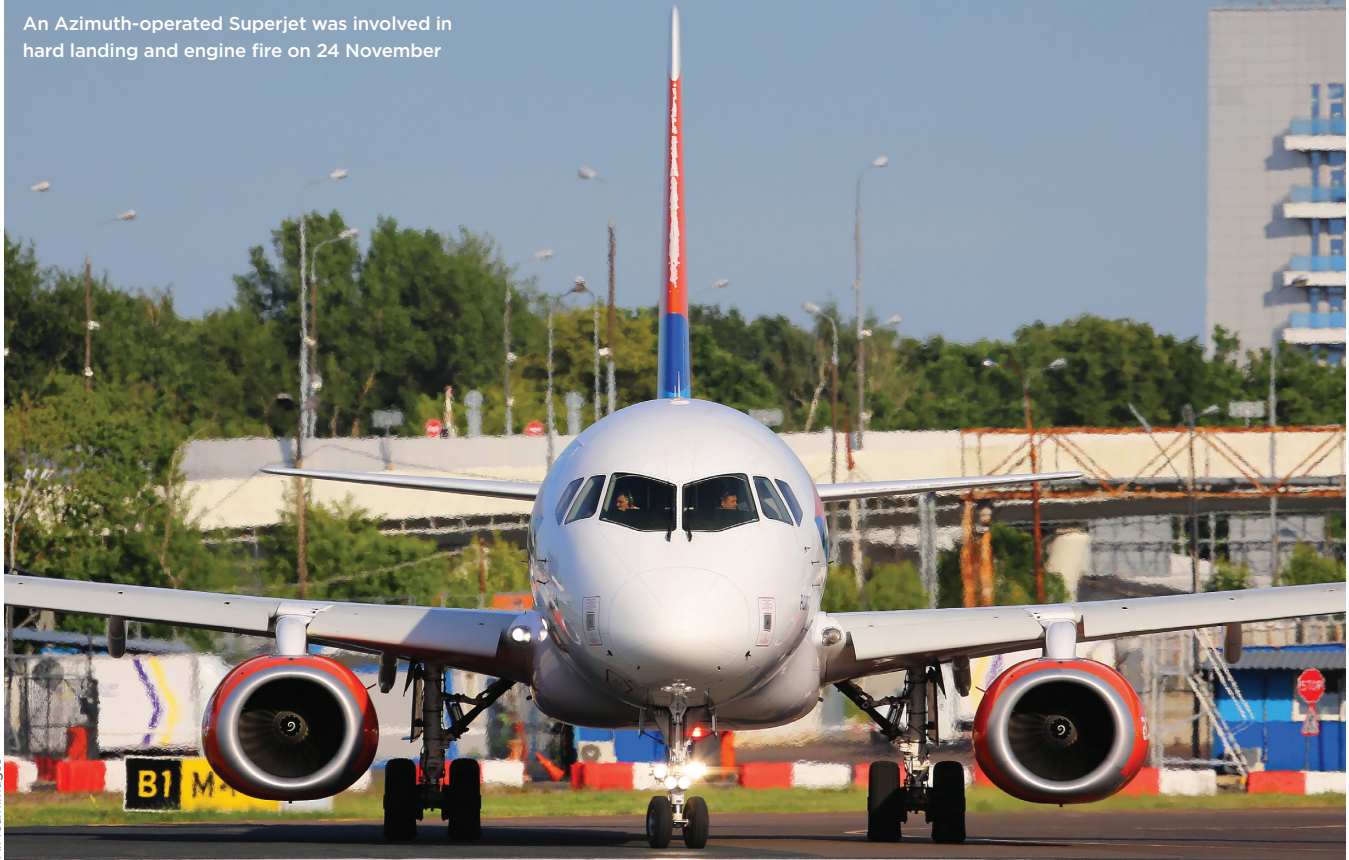
An Azimuth-operated Superjet was involved in hard landing and engine fire on 24 November
