# Accidents and incidents

## January-June 2020

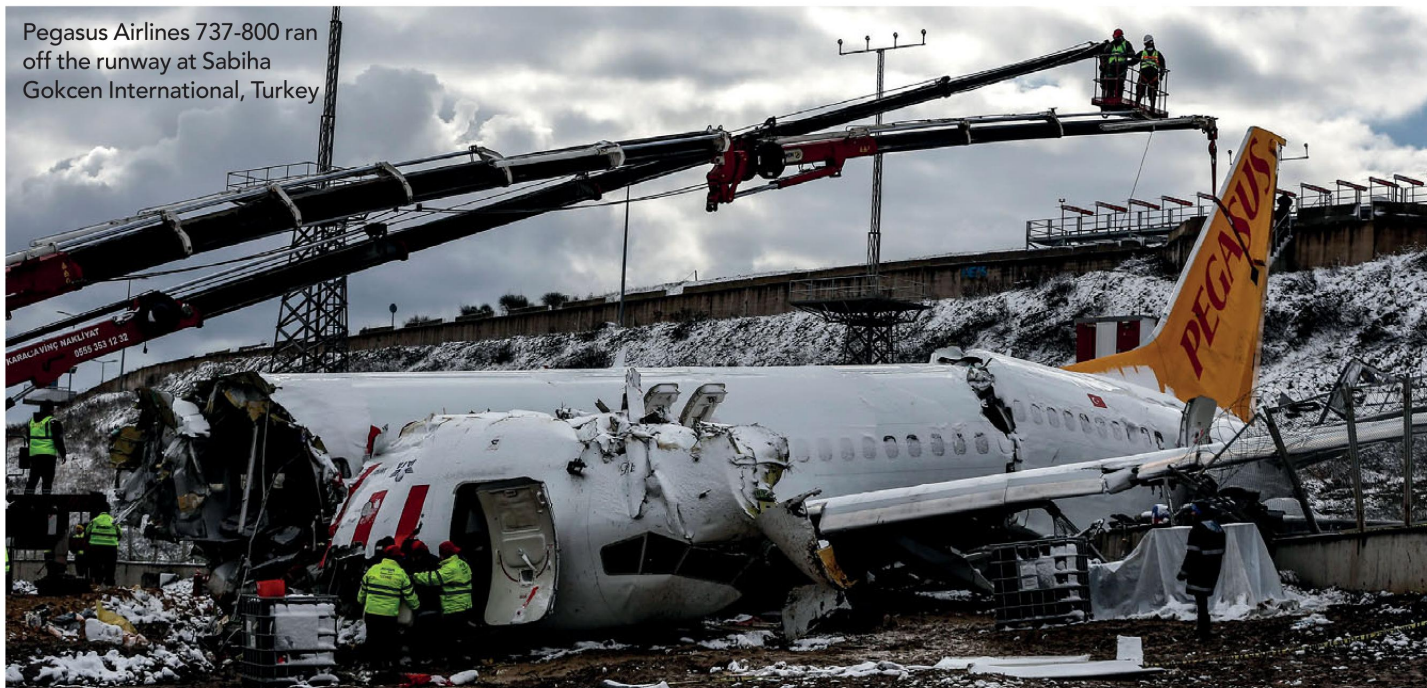
5 Feb	Pegasus Airlines	Boeing 737-800 (TC-IZK)	Istanbul Sabiha Gokcen airport, Turkey	0/3	6/177	L
<p>The aircraft, inbound from Izmir, was approaching runway 06 while a thunderstorm was passing and the wind direction was changing rapidly. On final approach, the aircraft had a normal approach airspeed but a tailwind component of about 20kt (37km/h), and it landed long and fast. The crew used autobrake and spoilers, and applied reverse thrust manually, but the aircraft went over the runway end, fell down a 30m (100ft) slope and broke into three sections. Three passengers died and most of those who survived were injured. The accident happened in darkness (18:19 local time) and in IMC with strong gusting winds and rain associated with local thunderstorm activity – wind 290° at 22kt gusting to 37kt and variable between 240° and 330°. Visibility was 3.8nm (7km) in rain. Runway 06 has a landing distance available of 3,000m (9,840ft) with a 60m stopway. The runway surface is concrete. The runway was wet. It is understood that Runway 06 at Sabiha Gokcen is the preferred runway unless it is wet and the tailwind component exceeds 5kt. The aircraft was operating flight PC2193.</p>

Pegasus Airlines 737-800 ran off the runway at Sabiha Gokcen International, Turkey

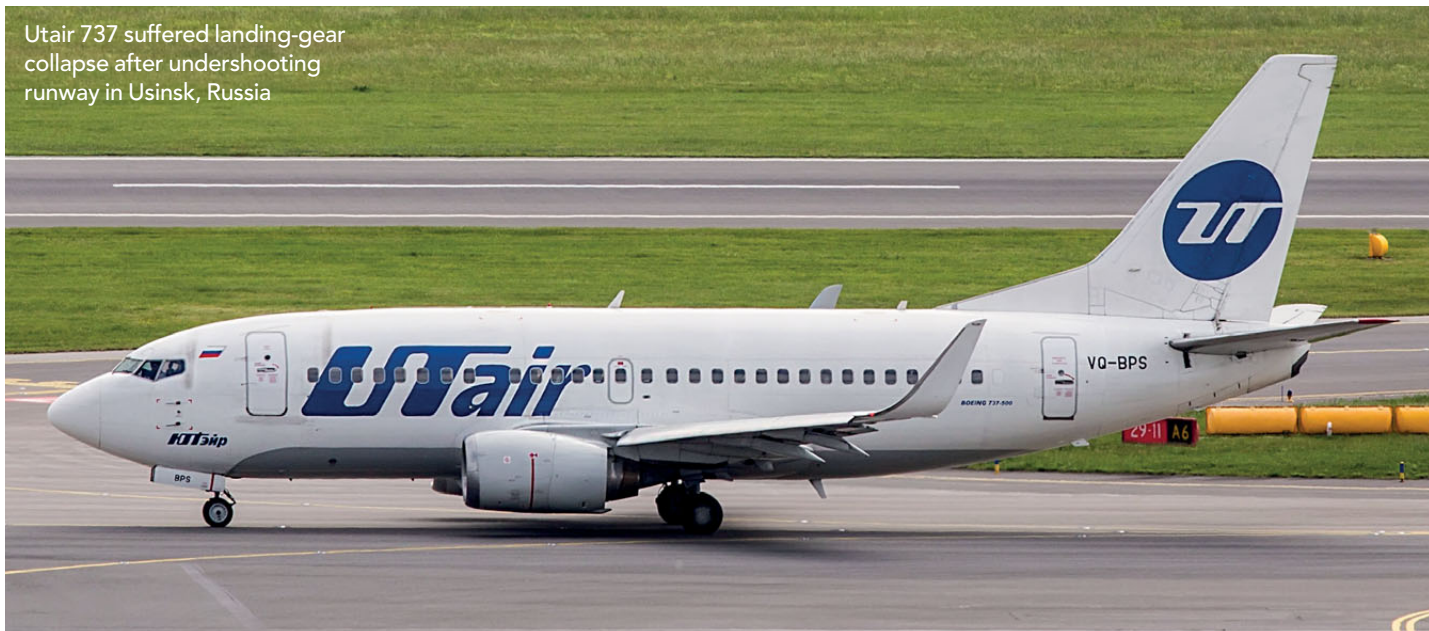
Utair 737 suffered landing-gear collapse after undershooting runway in Usinsk, Russia
