Fatal accidents:

Scheduled passenger flights

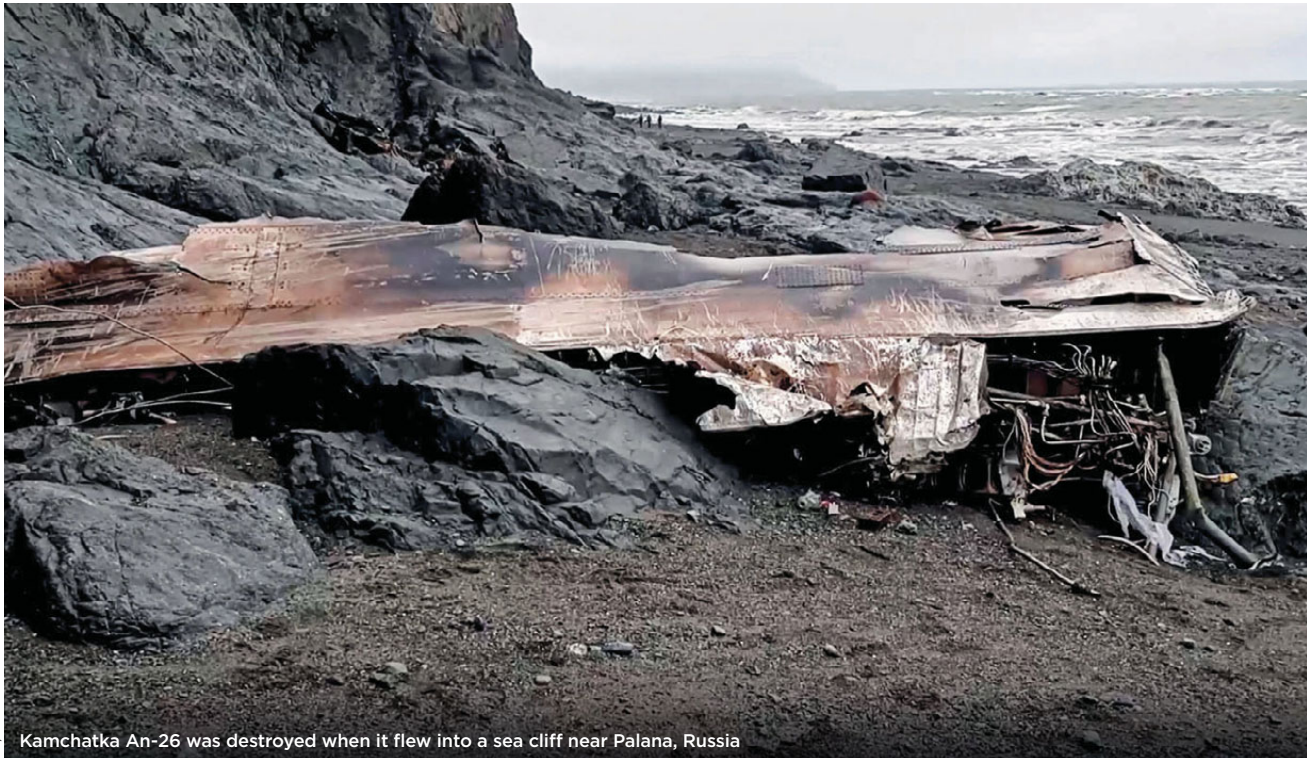
Kamchatka An-26 was destroyed when it flew into a sea cliff near Palana, Russia

The aircraft was destroyed when it flew into the top of a high sea cliff on final approach to runway 12 at Palana, Kamchatka Krai, Russia. The accident site is about 3.6km northwest of the airfield. Last contact with the flight, which was apparently routine, was when it was about 5nm (9km) from Palana, commencing its approach. The airfield elevation is

34m (111ft). The cliff and the slope behind it rise to 261m. The accident happened in daylight (15:00 local time); weather, strong south/south-westerly wind, visibility 10km but with localised fog patches and cloud, broken at 1,000ft and overcast at 2,400ft. The aircraft was operating a flight from Petropavlovsk-Kamchatsky.

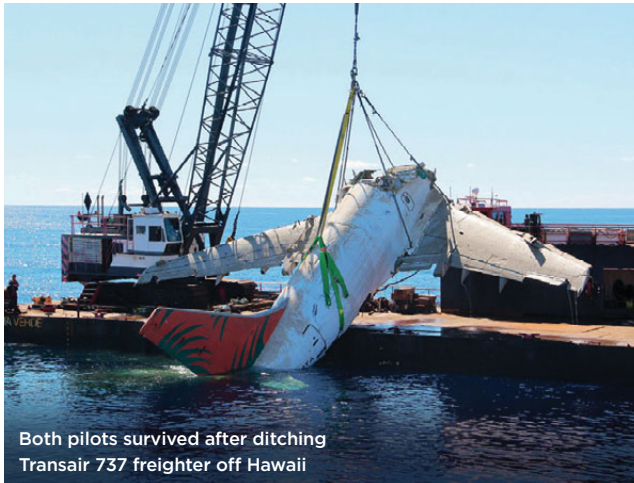
Both pilots survived after ditching Transair 737 freighter off Hawaii

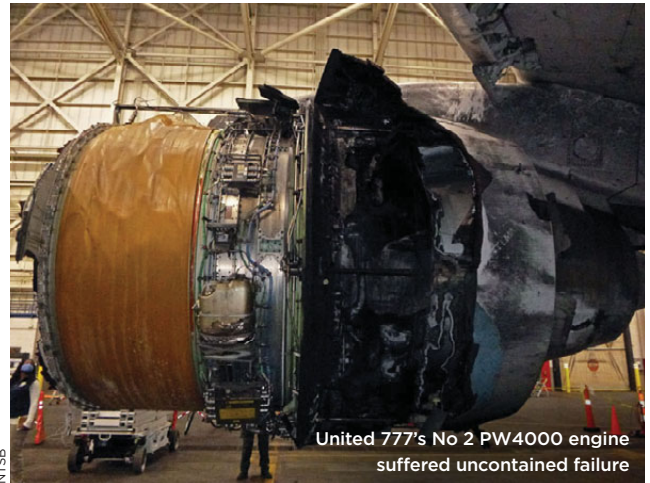
The Boeing 777-200's No 2 Pratt & Whitney PW4000 engine suffered a multiple fan blade failure as it was climbing through about 12,500ft at 280kt (518km/h) after take-off from runway 25 at Denver International airport. Following the failure the engine's inlet and fan cowl detached and broke away from the aircraft, falling in the residential district of Broomfield some 30km northeast of the airport. The falling debris damaged the roof of a house and a parked vehicle. A fire broke out in the aft section of the engine and continued to burn until put out by the airport fire service after it returned to Denver and landed safely.

The incident happened in daylight (13:07 local time), and VMC. The aircraft was operating a flight to Honolulu, Hawaii. Further investigation identified multiple fatigue fracture origins on the interior surface of a cavity within one blade, and a second blade had also failed but in overload. When the blade failed, the engine had been in service for 2,979 flight cycles since its previous inspection. It had undergone thermal acoustic image inspections in 2014 and 2016, and the 2016 data had been re-examined in 2018 following a similar in-flight failure that year of another PW4000.

United 777's No 2 PW4000 engine suffered uncontained failure

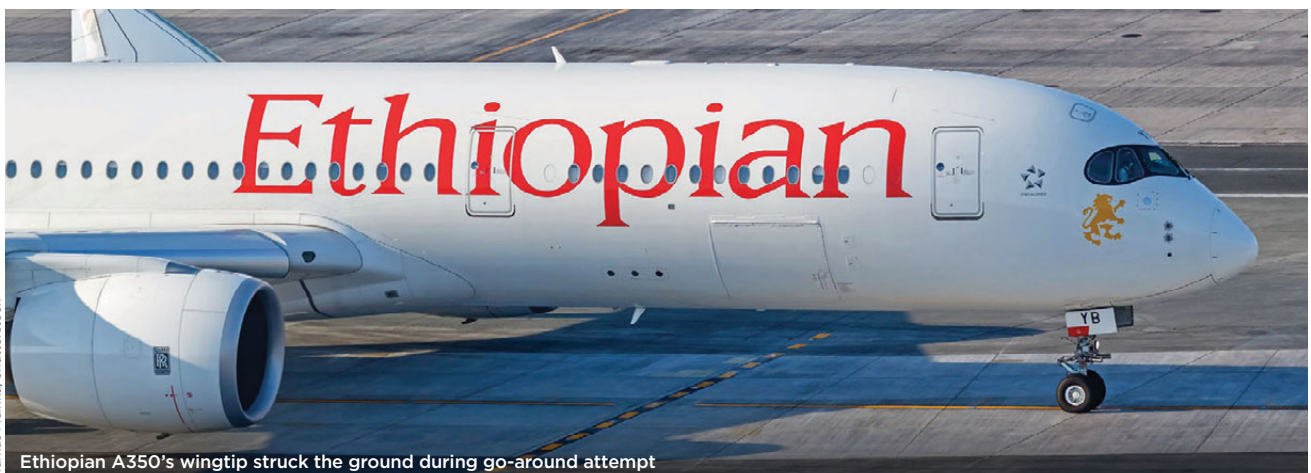
Ethiopian A350's wingtip struck the ground during go-around attempt
