Fatal accidents:

## Regional and commuter flights

Significant non-fatal accidents/incidents:

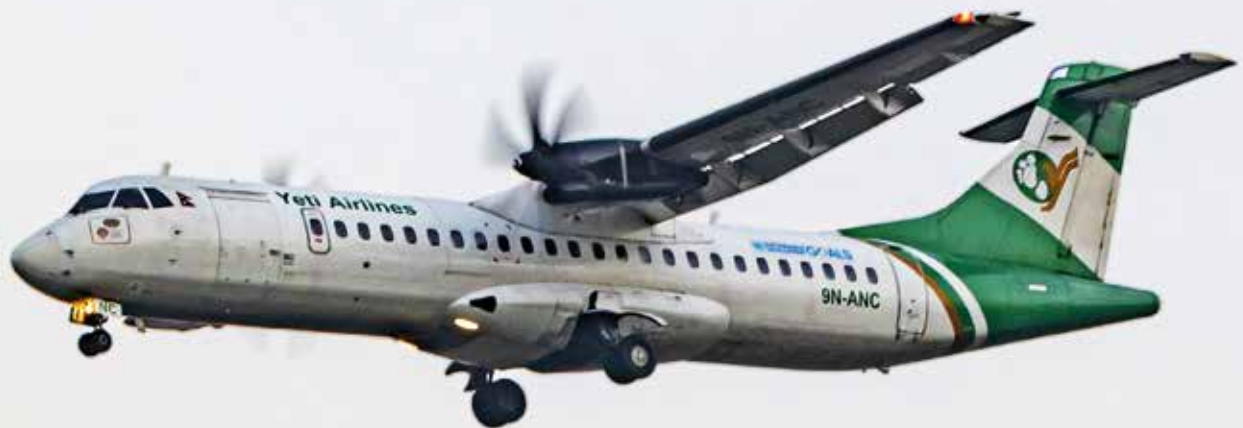
All on board Yeti Airlines ATR 72-500 were killed when it crashed in January

**Date:** 15 Jan ● **Carrier:** Yeti Airlines ● **Aircraft type/registration:** ATR 72-500 (9N-ANC) ● **Location:** Near Pokhara International airport, Nepal  
**Fatalities (crew/pax):** 4/68 ● **Total occupants (crew/pax):** 4/68 ● **Phase:** Runway approach

Inbound from Kathmandu, the aircraft descended to join a visual downwind leg for runway 12, positioned to turn left onto base leg and final approach. The pilot flying (PF), in the left-hand seat, was being checked out on the Pokhara approach by the pilot monitoring (PM). According to the Nepalese investigator's preliminary report, the crew selected flaps to 15° and gear down, and the PF disengaged the autopilot at about 700ft above ground level (AGL). The PF called for flaps 30, and the PM responded "flaps 30 and descending". According to the flight-data recorder, however, the flaps remained at 15°, but at the same time the propeller RPM and engine torque on both sides decreased dramatically, and the Master Caution alert chimed. The crew began the "Before Landing" checklist just before turning left onto the base leg.

The PF reacted to the decreasing airspeed by advancing the power levers, but there was no reaction. Then the flaps were extended to 30° with no announcement. The aircraft was passing 500ft AGL, and shortly after that the air traffic control tower cleared the aircraft to land. The PF exclaimed that there was no power, and he advanced the power levers to the maximum setting. There was a click sound, and the high-pressure turbine speed on both engines increased, but the PF repeated that there was no power from the engines, and the PM took control. The stick-shaker activated twice, the left wing dropped dramatically, and the aircraft plunged to earth more or less on the runway extended centreline, hitting a river ravine 1nm (2km) short of the threshold. All on board were killed.

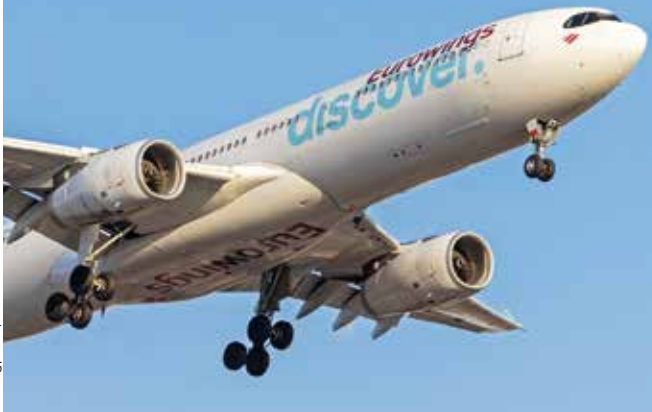
**Date:** 19 Feb ● **Carrier:** Eurowings Discover ● **Aircraft type/registration:** Airbus A330 (D-AXGB) ● **Location:** Windhoek, Namibia  
**Injuries (crew/pax):** 0/0 ● **Total occupants (crew/pax):** 11/263 ● **Phase:** Landing

Inbound from Frankfurt, Germany, the aircraft sustained substantial damage in a hard landing on runway 26 at Windhoek International airport. The accident happened in daylight and good visibility. The preliminary investigation reported that, following a stabilised approach,

the landing flare was initiated late and the aircraft touched down hard. There were no injuries among the occupants of the aircraft. The landing was performed by the co-pilot on his first flight on the A330 following initial type rating. Airfield elevation is 5,640ft.

A330 was damaged in a hard landing at Windhoek, Namibia in February

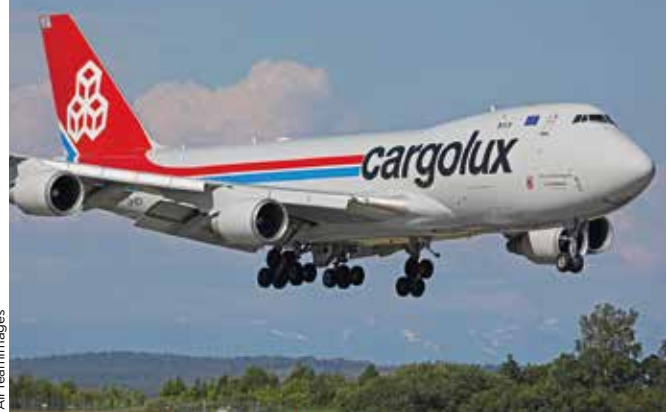
747 freighter's left-hand engines struck ground in 15 April incident

**Date:** 15 Apr ● **Carrier:** Cargolux ● **Aircraft type/registration:** Boeing 747-400ERF (LX-ECV) ● **Location:** Luxembourg airport, Luxembourg  
**Injuries (crew/pax):** 0/0 ● **Total occupants (crew/pax):** ?/? ● **Phase:** Landing

The 747 freighter was inbound from Dubai landing on runway 06 at Luxembourg airport, when the No 1 and 2 engines struck the ground. The crew flew a successful go-around and returned for a safe landing.

An inquiry determined that there was a significant shift in the wind speed and direction at the time of the flare for landing, and the engine strike was not the result of crew control inputs.
