Yeti Airlines ATR 72 crashed after pilot feathered both propellers

Fatal accidents:

Significant non-fatal accidents/incidents:

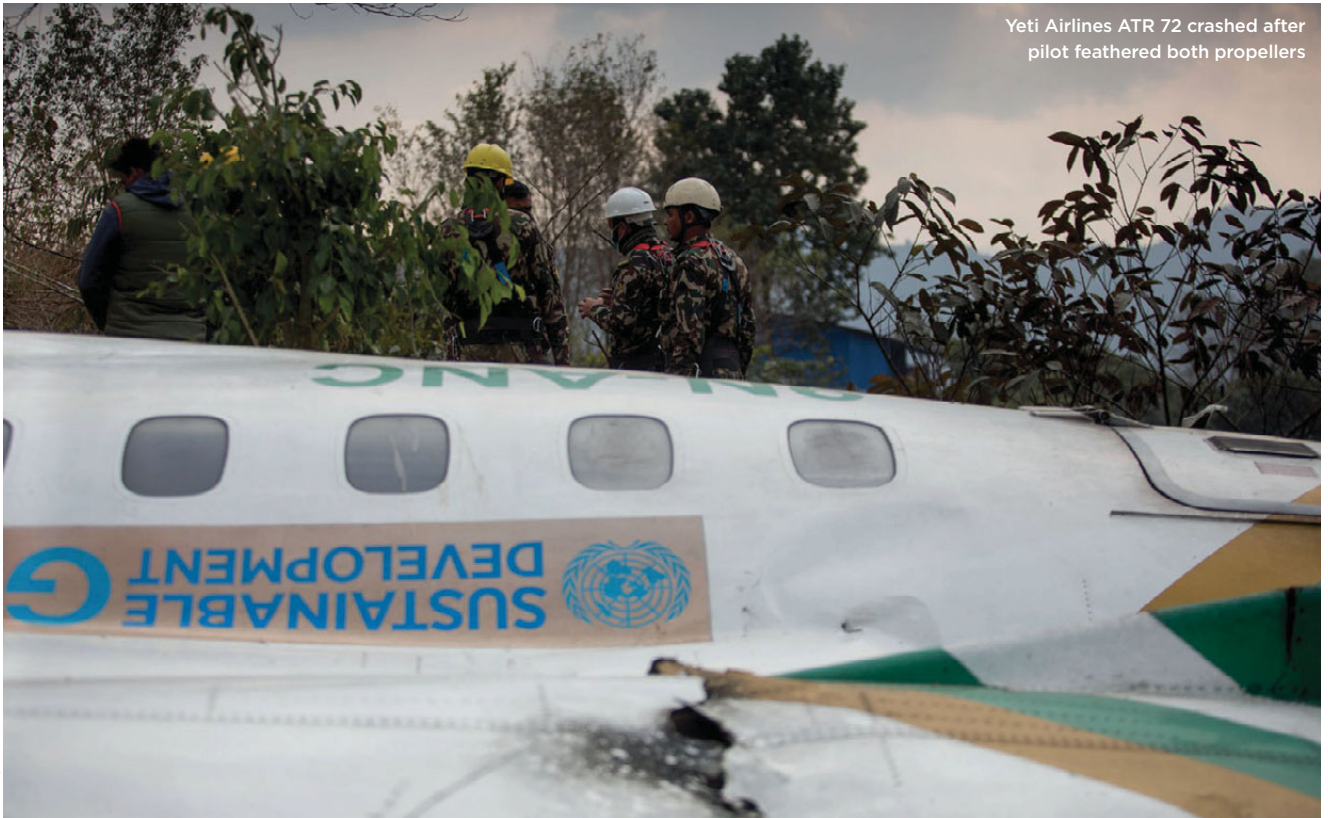
Date: 15 Jan ● **Carrier:** Yeti Airlines ● **Aircraft type/registration:** ATR 72-500 (9N-ANC) ● **Location:** Near Pokhara International airport, Nepal
Fatalities (crew/pax): 4/68 ● **Total occupants (crew/pax):** 4/68 ● **Phase:** Runway approach

Inbound from Kathmandu, the aircraft descended to join a visual downwind leg for runway 12, positioned to turn left onto base leg and final approach. The pilot flying (PF), in the left-hand seat, was being checked out on the Pokhara approach by the pilot monitoring (PM), an instructor. According to the Nepalese investigator's report the crew selected flaps to 15° and gear down, and the PF disengaged the autopilot at about 700ft above ground level (AGL). The PF called for flaps 30, and the PM responded "flaps 30 and descending". According to the flight-data recorder, however, the flaps remained at 15°, but at the same time the propeller RPM and engine torque on both sides decreased dramatically, and the Master Caution alert chimed. The Nepalese authorities have now reported their acceptance that the instructor had retarded the propeller condition levers while intending

to lower the flaps. The crew began the 'Before Landing' checklist just before turning left onto the base leg. The PF reacted to the decreasing airspeed by advancing the power levers, but there was no reaction. Then the flaps were extended to 30° with no announcement. The aircraft was passing 500ft AGL, and shortly after that the air traffic control tower cleared it to land. The PF exclaimed that there was no power, and he advanced the power levers to the maximum setting. There was a click sound, and the high-pressure turbine speed on both engines increased, but the PF repeated that there was no power from the engines, and the PM took control. The stick-shaker activated twice, the left wing dropped dramatically, and the aircraft plunged to earth more or less on the runway extended centreline, hitting a river ravine 1nm (2km) short of the threshold. All 72 on board were killed.

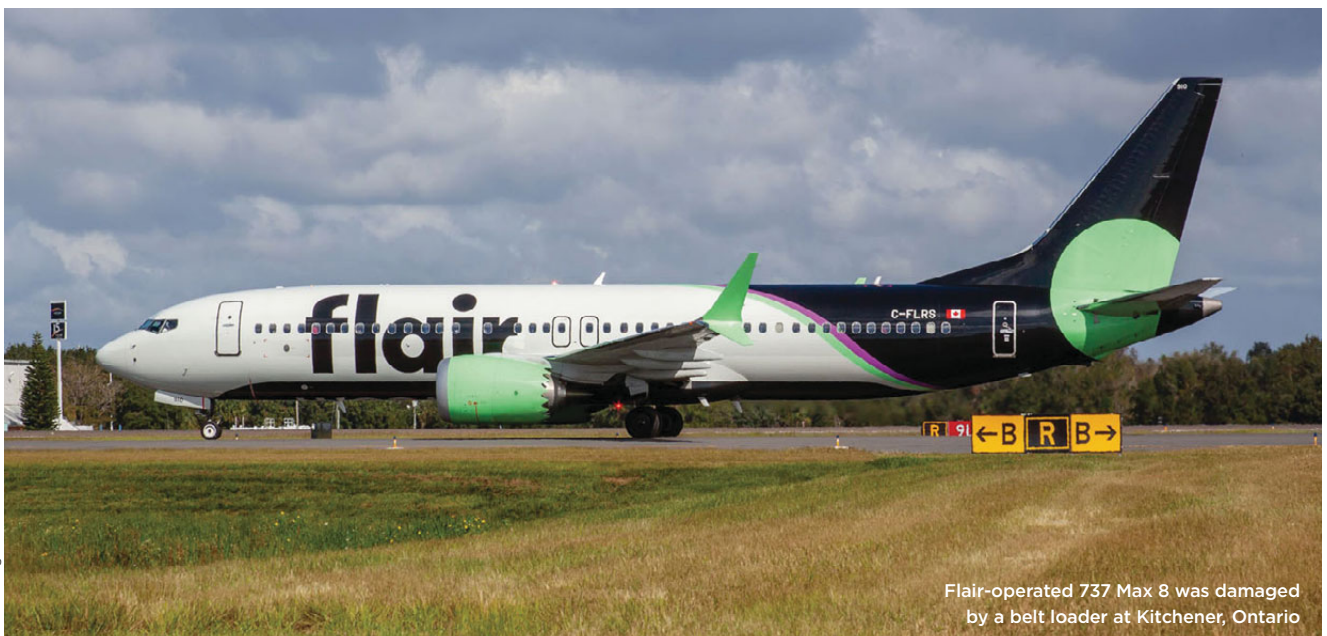
Date: 1 Jan ● **Carrier:** Flair Airlines ● **Aircraft type/registration:** Boeing 737 Max 8 (C-FLRS) ● **Location:** Kitchener, Ontario, Canada
Injuries (crew/pax): 0/0 ● **Total occupants (crew/pax):** 6/148 ● **Phase:** On ground

Preparing to depart from Region of Waterloo International airport, a belt loader driver inadvertently selected a forward gear instead of reverse while attempting to move his vehicle away from the aft cargo hold. The belt loader ran forward into the aircraft, knocking the driver off his seat.

Driverless, it continued under the aircraft, damaging the aft belly skins and proceeding across the ramp until it struck a parked Sunwing Airlines Boeing 737-800 (C-GFEH). The accident happened in darkness (07:00 local time). The aircraft was due to operate a flight to Cancun, Mexico.

Flair-operated 737 Max 8 was damaged by a belt loader at Kitchener, Ontario

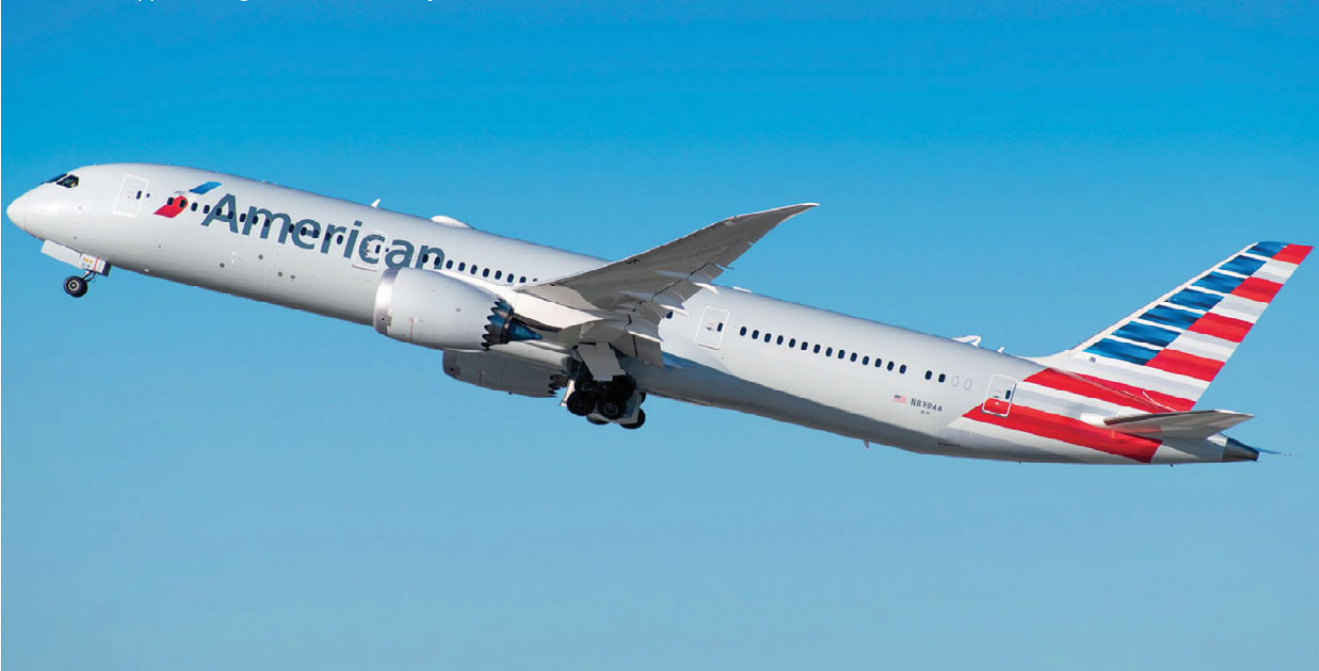
Date: 20 Feb ● **Carrier:** American Airlines ● **Aircraft type/registration:** Boeing 787-9 (N839AA) ● **Location:** Dallas/Fort Worth airport, Texas, USA
Injuries (crew/pax): 0/0 ● **Total occupants (crew/pax):** ?/? ● **Phase:** En route

The aircraft, inbound from Tokyo Narita, Japan, suffered a lightning strike to the top of its fuselage at some point on the journey. There was visible

heat damage covering an area of about 0.5m x 0.2m. The aircraft landed safely and the passengers disembarked normally at the gate.

American Airlines 787-9 suffered a lightning strike to its upper fuselage en route from Tokyo

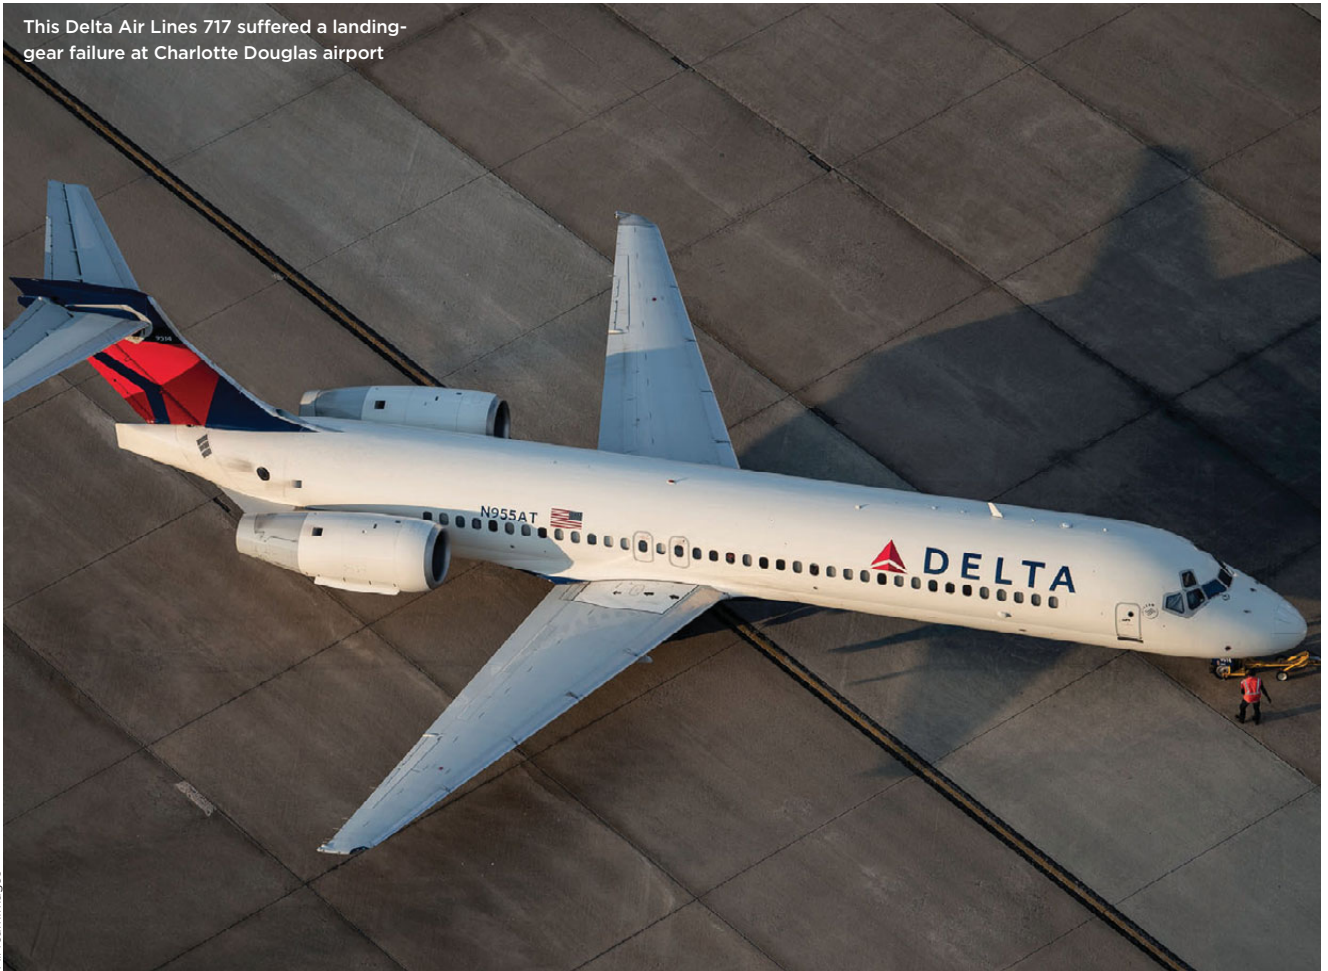
This Delta Air Lines 717 suffered a landing-gear failure at Charlotte Douglas airport

On final approach to Charlotte Douglas, using the ILS for runway 36L, when the crew selected the landing gear down the nosewheel indicated "unsafe", and air traffic control told them they could not see the nosewheel. The crew carried out a go-around, and before returning made

various attempts to get the nose gear to deploy. When this failed, they made another approach and came to a halt safely on the runway. The fire and rescue service cooled the nosewheel area with water, and the passengers were evacuated via slides at the two front doors.

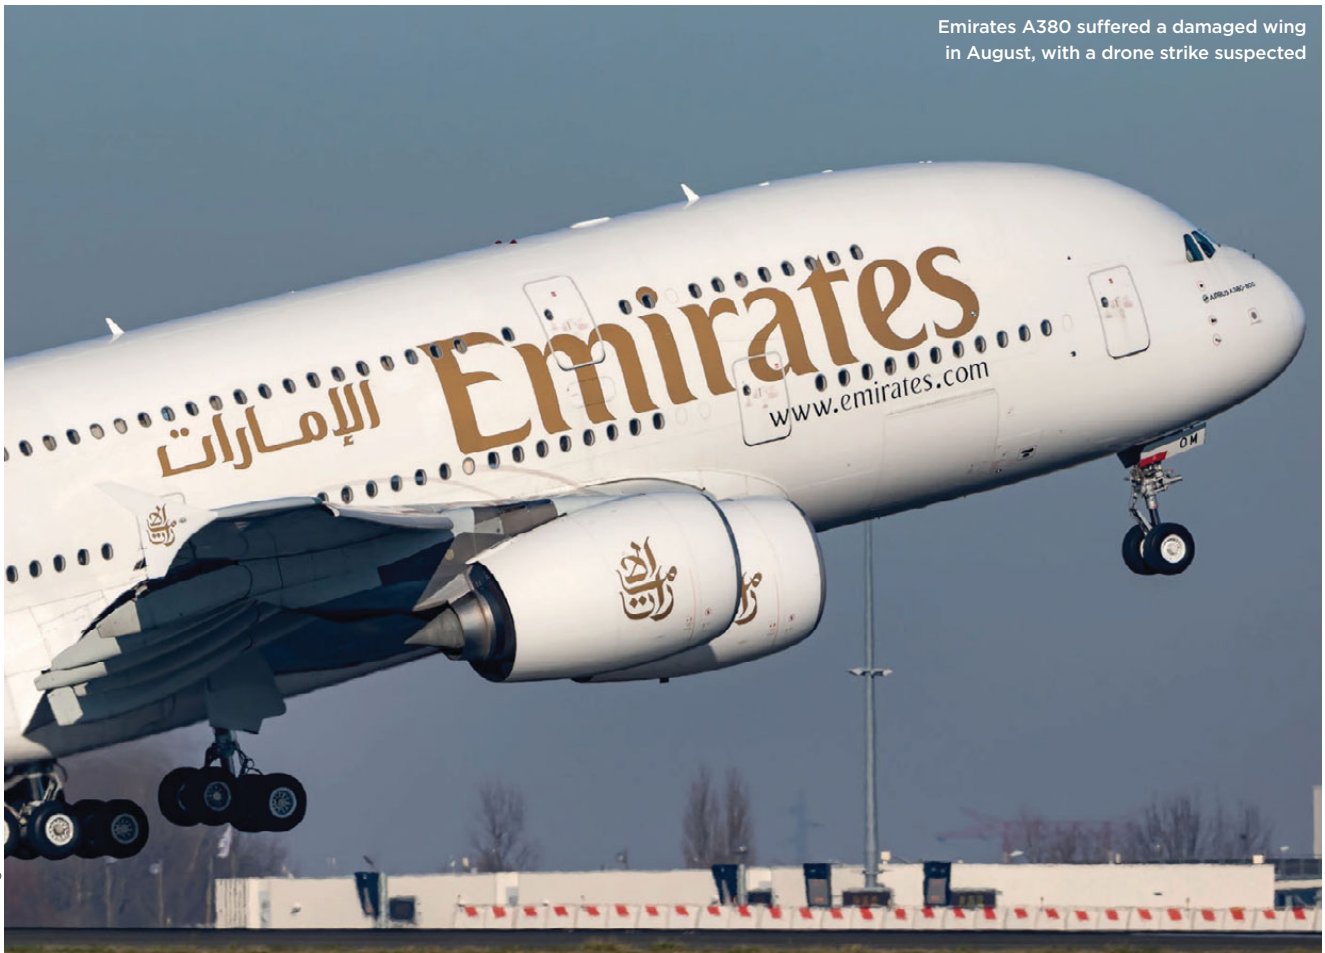
the approach and landing. After parking, one of the right wing leading edge slats was discovered to be badly damaged. Investigation into reports of a drone-strike is continuing.

Emirates A380 suffered a damaged wing in August, with a drone strike suspected
