Fatal accidents:

Scheduled passenger flights

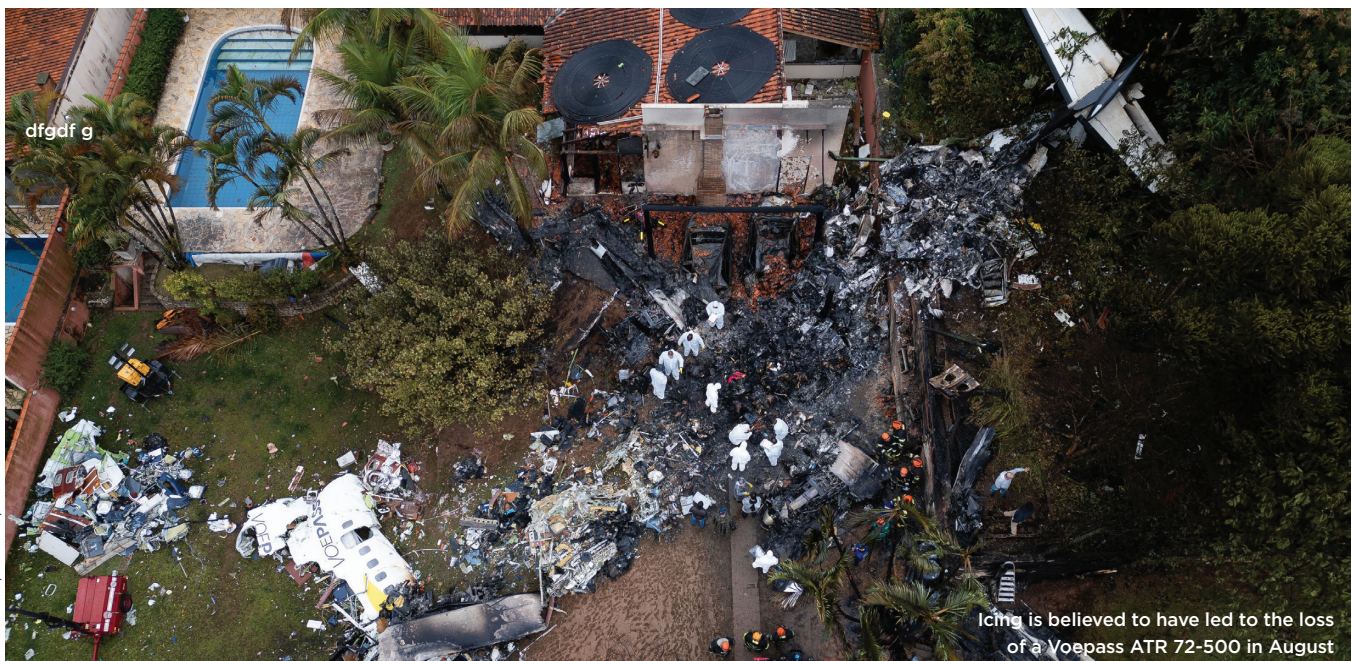
Just before the top of its descent into Sao Paulo Guarulhos the aircraft was in normal cruise flight at 17,000ft. At 16:20 local time, air traffic control cleared the aircraft to turn right towards Sanpa. The aircraft began the turn but then seems to have stalled and entered an increasingly tight descending right turn. Control was not regained and it crashed. The accident happened in daylight, instrument meteorological conditions. There had been SIGMET warnings of severe icing valid at the time. There also had been warnings about icing conditions from early in the flight. At 15:14 – 16min after take-off – while climbing through 13,000ft the centralised crew alert system displayed an alert signal and 1min later the airframe de-icing was turned on; seconds later a single chime sounded. The crew comment-

ed on an airframe de-icing system fault, and it was turned off. The flight continued with the ice detection system intermittently emitting the alert signal for the next 1h. At 16:17 the airframe de-icing was turned on again, and 1min later, while at a speed of 191kt (353km/h), the cruise speed low alert was triggered. The crew did not comment on this and, at 16:19 the de-icing system was again turned off, followed by the aircraft's degraded performance alert being triggered at 184kt. The cockpit voice recorder (CVR) captured the co-pilot as commenting at 16:20 that there was "a lot of icing". Around 30s later, with the aircraft travelling at 169kt, the increase speed alert was triggered. Immediately afterwards, vibration noise is captured on the CVR with the stall alert, and control of the aircraft was lost.
